Evaluation of Damage to a Historic Masonry Building in Nepal through Comparison of Dynamic Characteristics before and after the 2015 Gorkha Earthquake

Aiko Furukawa^{1*}, Junji Kiyono¹, Rishi Ram Parajuli¹, Hari Ram Parajuli² and Kenzo Toki³

¹Department of Urban Management, Graduate School of Engineering, Kyoto University, Kyoto, Japan, ²National Reconstruction Authority, Government of Nepal, Kathmandu, Nepal, ³Institute of Disaster Mitigation for Urban Cultural Heritage, Ritsumeikan University, Kyoto, Japan

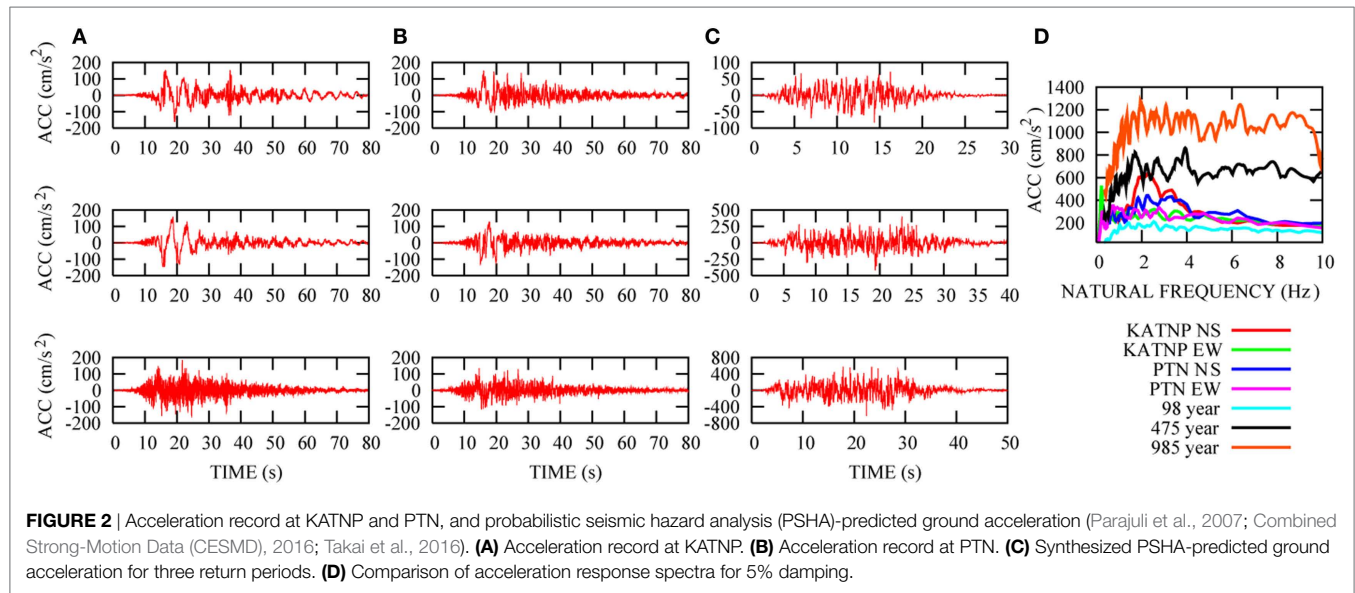
Figure 2A shows the accelerogram observed at KATNP [Combined Strong-Motion Data (CESMD), 2016]. The peak ground accelerations for the NS, EW, and UD components are 162, 155, and 184 cm/s^2 , respectively.

Figure 2B shows the accelerogram observed at PTN (Takai et al., 2016). The peak ground accelerations for the NS, EW, and UD components are 151, 128, and 133 cm/s^2 , respectively, which are smaller than those of KATNP.

FIGURE 2 | Acceleration record at KATNP and PTN, and probabilistic seismic hazard analysis (PSHA)-predicted ground acceleration (Parajuli et al., 2007; Combined Strong-Motion Data (CESMD), 2016; Takai et al., 2016). **(A)** Acceleration record at KATNP. **(B)** Acceleration record at PTN. **(C)** Synthesized PSHA-predicted ground acceleration for three return periods. **(D)** Comparison of acceleration response spectra for 5% damping.

As for the observed accelerations at KATNP, the NS component has the largest peak value of 638 cm/s² at 2.32 Hz and also has a peak value of 398 cm/s² at 0.21 Hz. The EW component has a peak value of 518 cm/s² at 0.22 Hz. A particular feature of this ground acceleration is that the predominant frequency is low.

As for the observed accelerations at PTN, the NS component has the largest peak value of 444 cm/s² at 2.27 Hz. The EW component has the largest peak value of 351 cm/s² at 0.72 Hz. The low frequency contents of PTN are smaller than that of KATNP.

The NS and EW components of the observed accelerations at KATNP and PTN were larger than the predicted ground accelerations with a return period of 98 years, but smaller than the predicted ground accelerations for return periods of 475 or 975 years. The acceleration spectra of the predicted ground motion were almost constant for frequencies from 2 to 10 Hz, while those of the observed accelerations at KATNP and PTN decreases with the increase of frequency from 2 to 10 Hz.

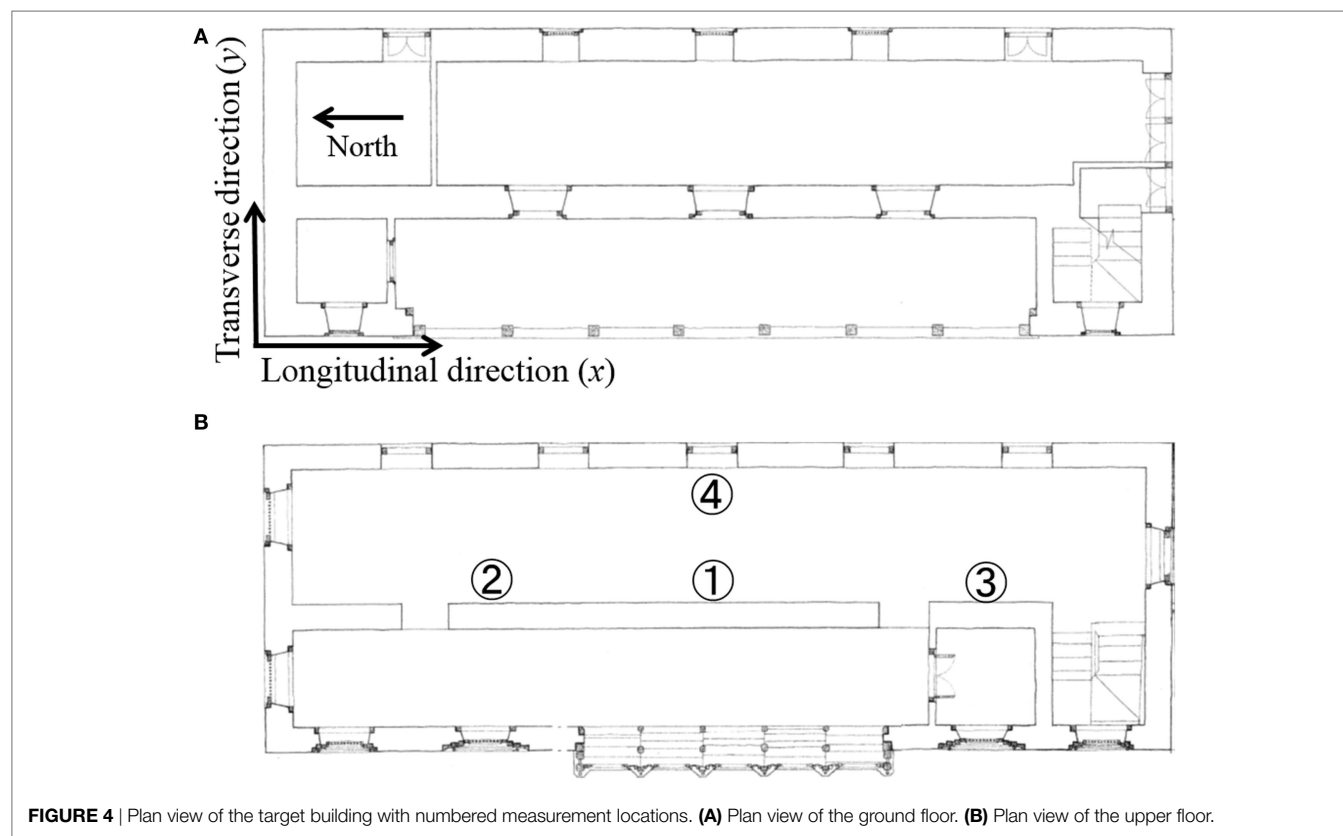
Figure 4A shows the layout of the structures and measurement locations where accelerometers were placed. The measurement was conducted at locations 1, 2, and 3 before the earthquake and at locations 1, 2, and 4 after the earthquake as shown in **Figure 4B**. The measurements at the same locations were not possible due to equipment trouble. The acceleration responses were measured for 10 min in the longitudinal (x , NS) and transverse (y , EW) directions. The sampling interval of measurement data was 0.01 s. The measured waveforms were corrected for baseline and divided into segments of 4,096 data points. 10 sets of 4,096 data points without unsteady portions were extracted manually and the average of their Fourier amplitudes was computed. For smoothing, Parzen window with a frequency band width of 0.4 Hz was applied.

FIGURE 4 | Plan view of the target building with numbered measurement locations. **(A)** Plan view of the ground floor. **(B)** Plan view of the upper floor.

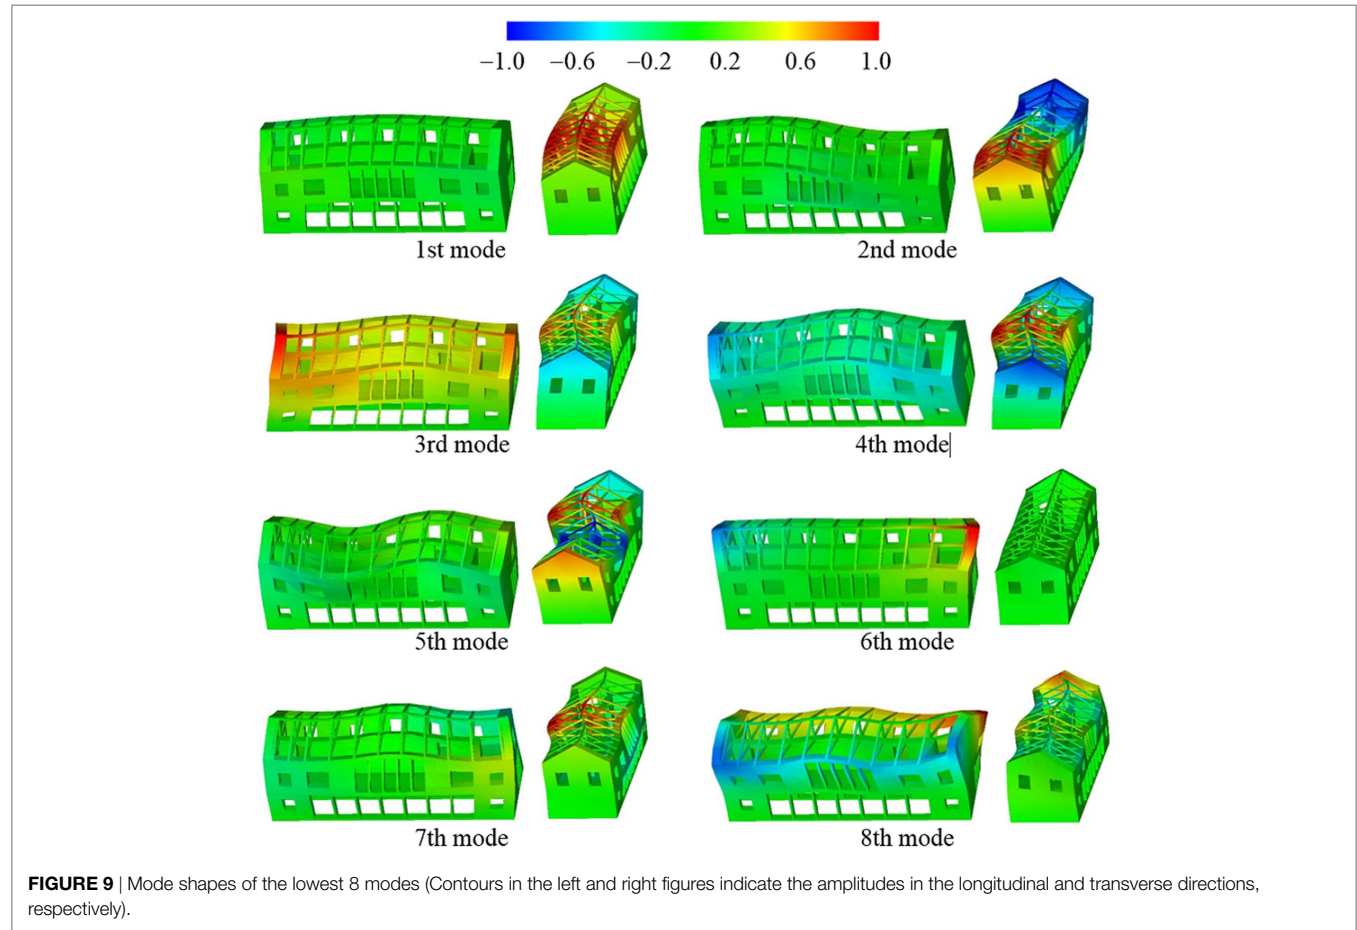
The mode shapes of the eight natural modes are shown in Figure 9. The eigenvector is scaled so that the largest absolute value of its elements be 1.0. Those mode shapes conform to the observed Fourier amplitude spectra shown in Figure 6. For example, the third, sixth, and eighth modes are dominant in the longitudinal (x) direction and other modes are dominant in the transverse (y) direction. In the second mode shown in Figure 9, the phases of the north and south side vibrations are opposite as observed in Figure 6C.

FIGURE 9 | Mode shapes of the lowest 8 modes (Contours in the left and right figures indicate the amplitudes in the longitudinal and transverse directions, respectively).
